Soil erosion and effects of erosion control works in the torrential drainage basins of southeast Serbia

STANIMIR KOSTADINOV & SLADANA MARKOVIĆ

Faculty of Forestry, Belgrade University, Kneza Višeslava 1, 11030 Belgrade, Yugoslavia

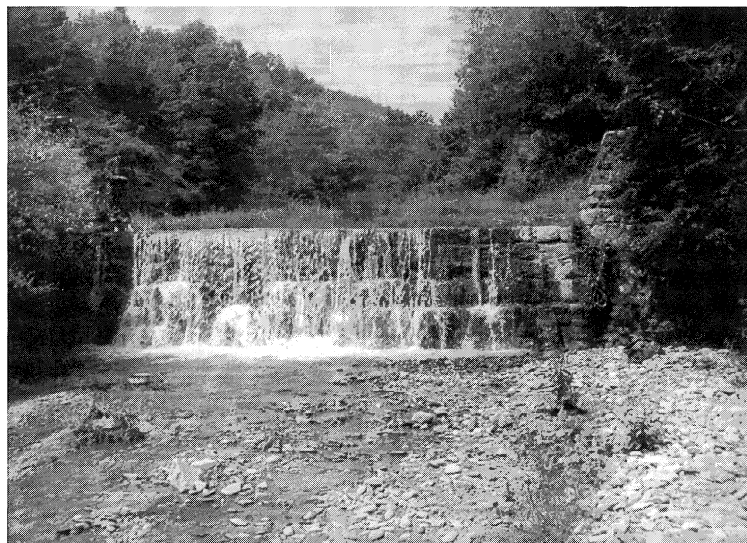
**Fig. 2** Check dam in the Kalimanska Reka torrent.

Erosion control works in the Lještarska Dolina drainage basin were carried out in the period 1963–1973. Details of the type and scope of ECW in all three drainage basins are given in Table 3, and examples of the structures built are presented in Figs 2, 3 and 4.

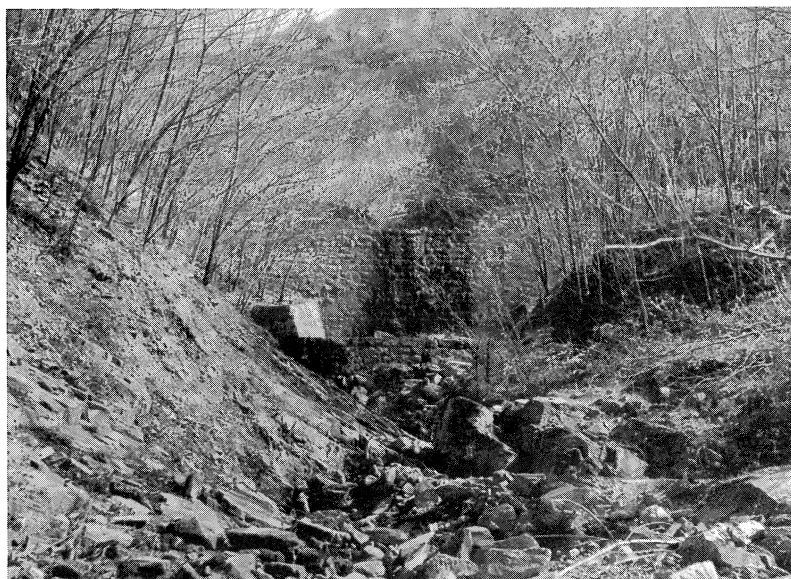
Fig. 3 Check dam in the Repinska Reka torrent.

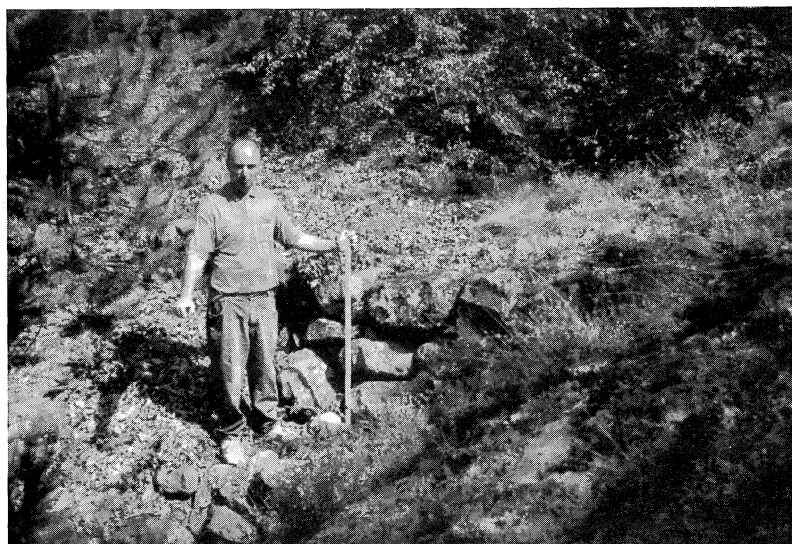
Fig. 4 Check dam of dry laid masonry and afforestation with Austrian pine (Lještarska Dolina drainage basin).
