Erosion of deposits from the pyroclastic flow that occurred on Mt Merapi, Indonesia in July 1998

Abstract A pyroclastic flow occurred on the southwest flank of Mt Merapi in Indonesia on 19 July 1998. As a result, a large mass of pyroclastic flow deposits filled the valley of the Sat River. In order to understand the gully erosion processes acting on the deposits, we conducted a cross-section survey and took photographs at fixed points within the site. The data obtained from the cross-section survey were used to calculate the sediment yield from gully erosion. The key findings are: (a) Rainfall occurring after the occurrence of the pyroclastic flow caused gully erosion on the deposits. Networks of gullies developed and their cross-sectional size increased rapidly during the first rainy season. (b) The total sediment yield from the gully erosion was estimated to be 680 000 m³ for the period extending from the occurrence of the pyroclastic flow until February 2000. Most of the sediment yield associated with the gully erosion occurred during the first half of the rainy season. There was no sediment yield from gully erosion during the dry season. (c) the annual specific sediment yield

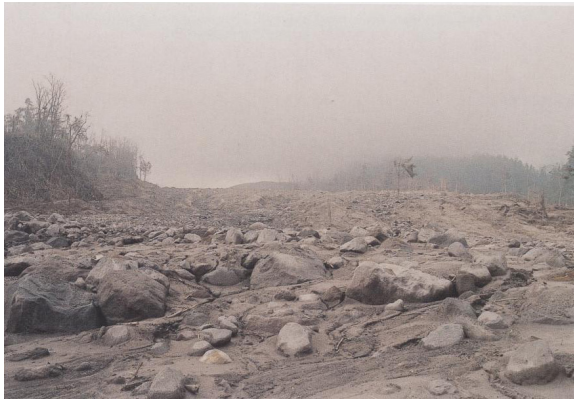
Photo 1 Fixed-point photograph taken on 6 August 1998. The gully is not yet visible.

Photographs 1 to 4 represent photographs taken on 6 August, 8 September, and 15 October 1998, and on 28 April 1999, respectively. These photographs show that gully erosion started to develop from September to October 1998, and increased greatly from October 1998 to April 1999. The results from another field survey showed that the depth and width of the gully cross-sections were about 10 m on 10 December 1998, and that both increased to between 25 and 30 m by mid May 1999. These findings show that the sediment deposited around the Sat River in July 1998 was rapidly eroded by the subsequent rainfall, forming large gullies during a short period of only a few months after the pyroclastic flow.

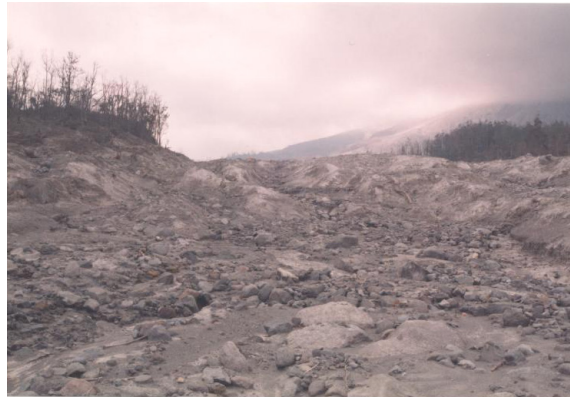
Photo 2 Fixed-point photograph taken on 8 September 1998. The gully is not yet visible.

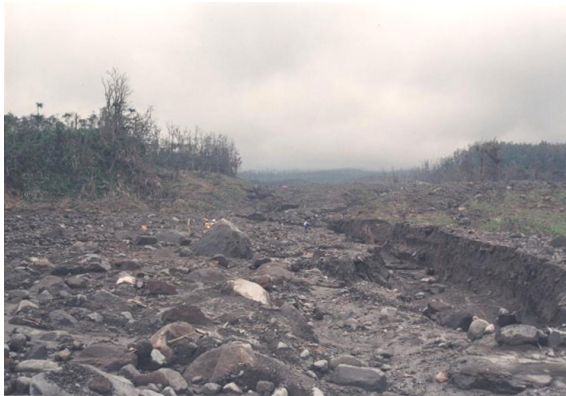
Photo 3 Fixed-point photograph taken on 15 October 1998. The gully is now clearly visible.

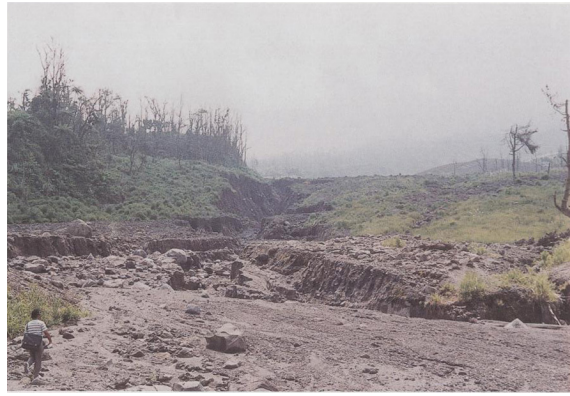
Photo 4 Fixed-point photograph taken on 28 April 1999. The gully is clearly visible.

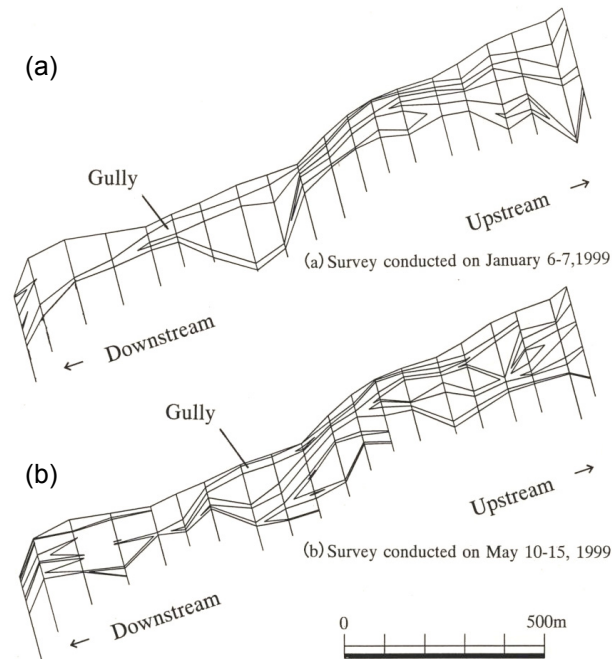
Fig. 4 A distribution map of the gullies developing on the pyroclastic deposit.

Gully network development Maps showing the spatial distribution of the gully network, based on the cross-section surveys, are presented in Figs 4(a) and (b). These show that there were more gullies and that the gully network was more developed in May after the rainy season than in January during the rainy season.

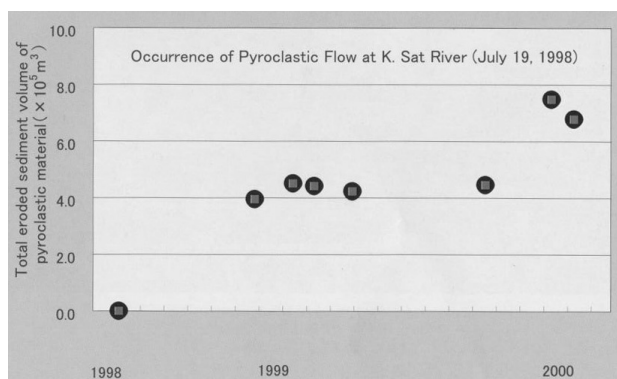
Fig. 5 Temporal variation of the volume of pyroclastic material eroded.

Based on the results of the cross-section surveys, the volume of the gully network over the survey range, which is equivalent the “total sediment yield by gully erosion”, was calculated by integrating the products of the cross-sectional areas of the gullies on the measurement lines and the distance between the measurement lines. The result of this calculation is shown in Fig. 5. The total sediment yield from gully erosion between July 1998 and February 2000 was approximately 680 000 m³. Approximately 430 000 m³ of gully erosion occurred by May 1999 during the first rainy season, while approximately 250 000 m³ occurred during the second rainy season from May 1999 to February 2000.

Figure 5 and the fixed-point photographs confirm that the total sediment yield from gully erosion increased from October to January for the first half of the rainy season, while it was almost constant during the second half of the rainy season and the dry season from May to October.
