Sedimentation behind barrages and oblique river flow

KAPILESWAR MISHRA¹ & DHRUBAJYOTI SEN²

Key words barrage; oblique flow; sedimentation; waterway; shoal development

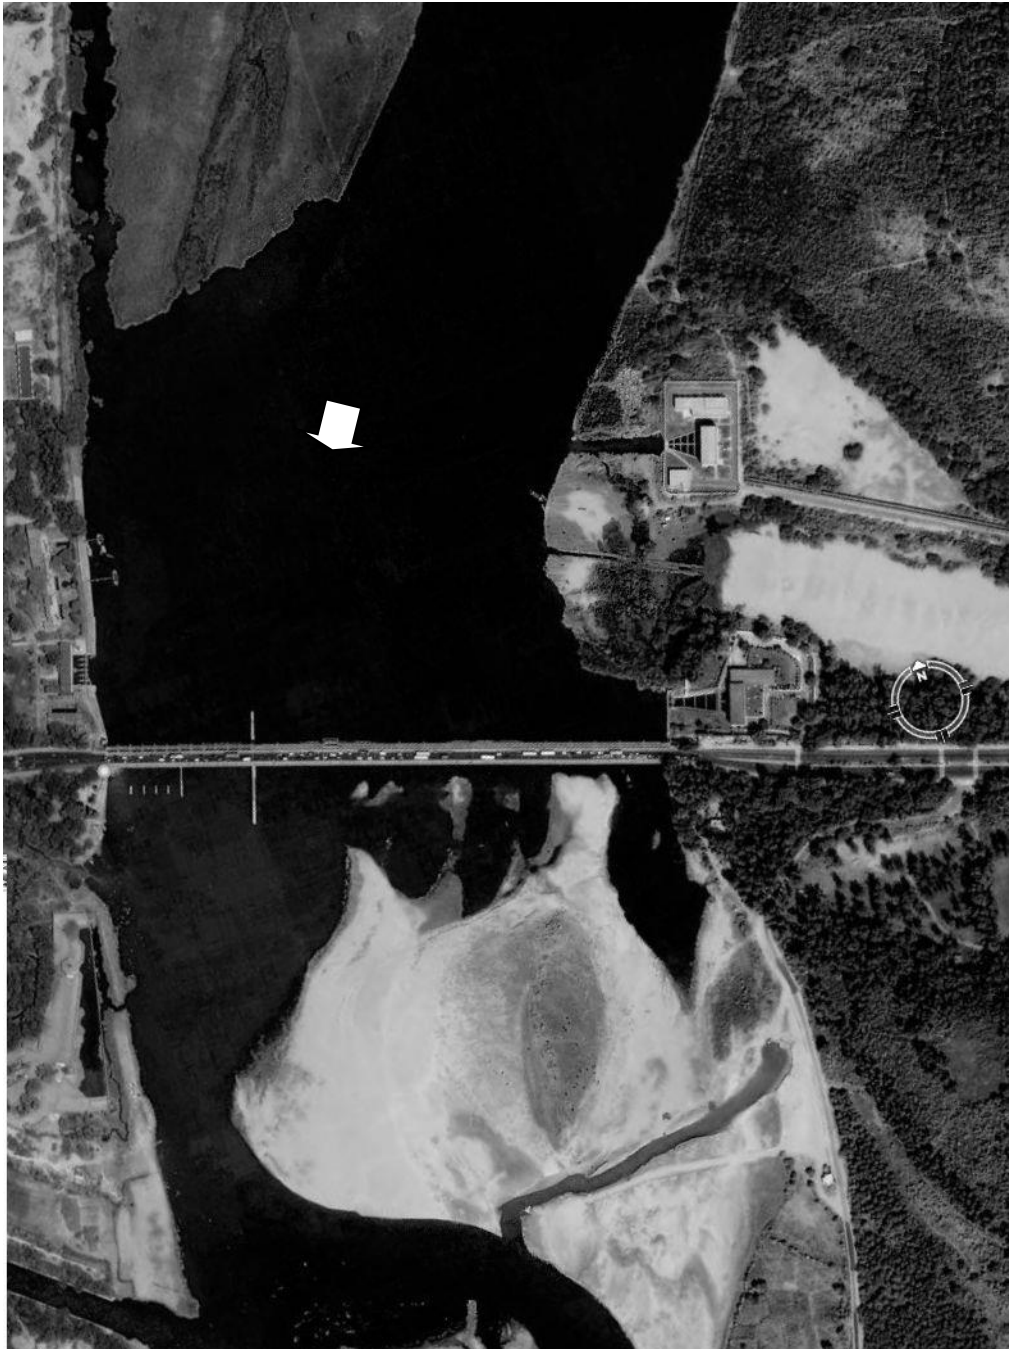
The river flow near this barrage supplying water to Delhi is inclined obliquely to the barrage axis on its upstream pool (Fig. 1). The original water off-take is located on the right bank (the divide wall and the undersluice bays may be seen towards this bank), a deep water channel has formed on that side. The left bank bays are obstructed by a protruding bank caused by deposition.

Fig. 1 The Wazirabad barrage on the River Yamuna, Delhi.

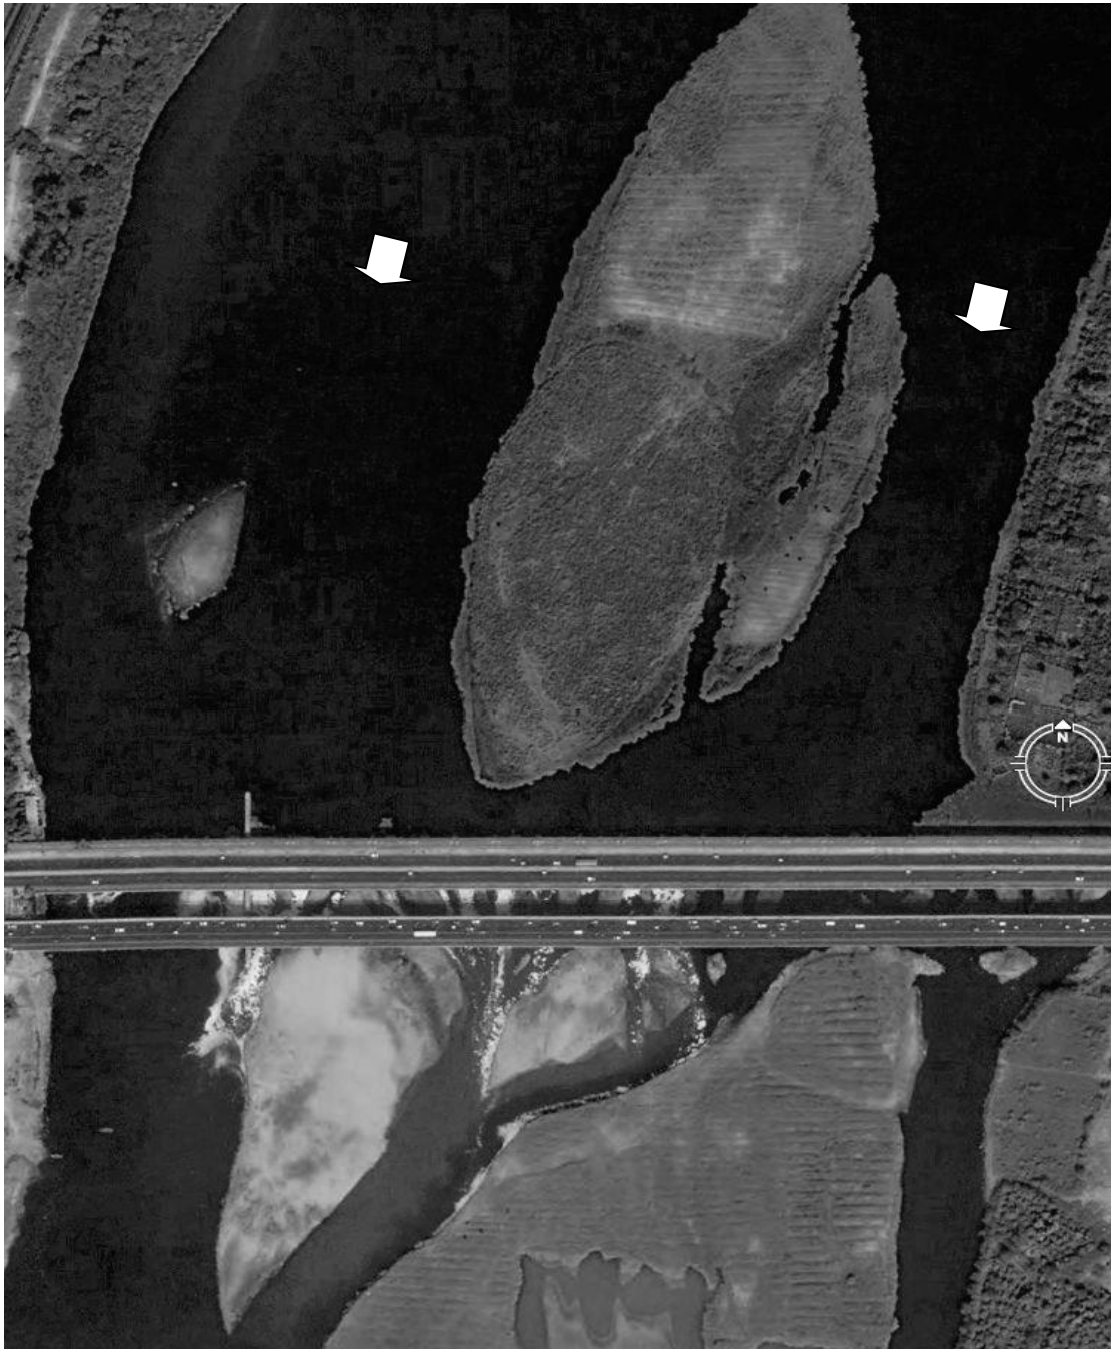
For this barrage (Fig. 2), used as a pond for drawing cooling water to a thermal power plant nearby on the right bank, a large shoal on the upstream pool may be observed, causing oblique flow. The shoal has, over the years, become very stable, with signs of vegetation appearing in places. Even during high floods, the shoal does not apparently erode. Probably, the use of artificial means such as dredging or blasting, etc. may have to be resorted to for its clearing. Here too, the water withdrawal from the right bank has led to the gates closer to this bank being kept open for longer durations. This is apparent from the formation of the large expanse of stabilized shoal near the left bank of the barrage on the downstream side.

Fig. 2 The barrage near ITO on the River Yamuna, Delhi.

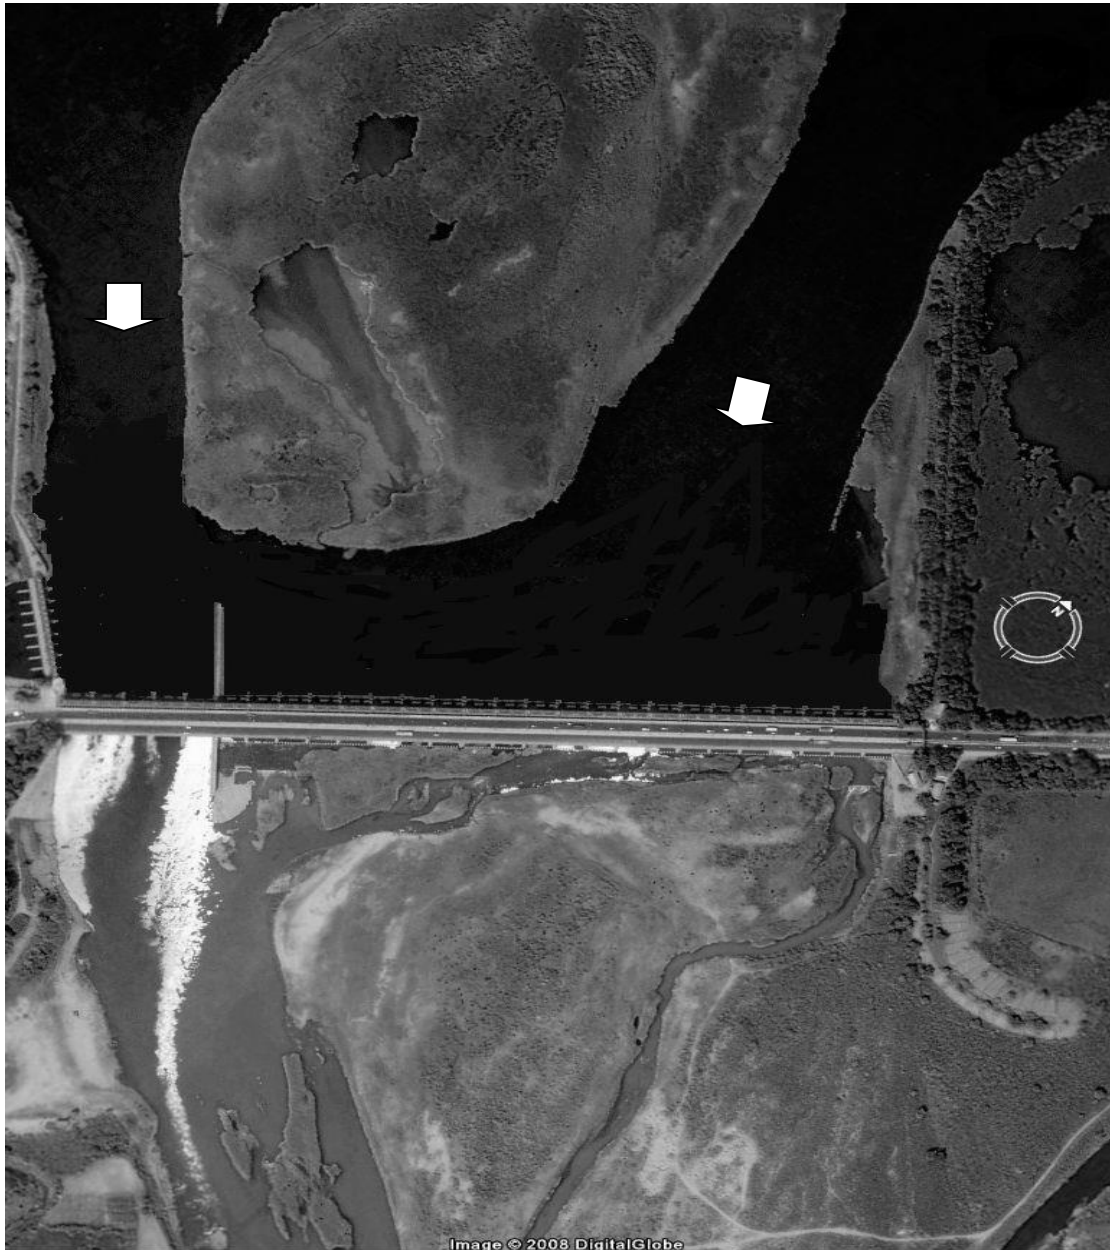
The Okhla barrage is used to divert water to the Agra Irrigation Canal (the offtake can be seen on the right bank, Fig. 3). This barrage was constructed to replace the century-old weir some distance upstream. However, the shoal formed in the pool of the barrage is much larger in size than that associated with the previous weir. It may be observed from the image (taken during the non-monsoon period and low flows, as the images are clear) that the shoal level rises much above the pool level. Therefore, most of the sediment must have been deposited during high floods of monsoons, and the oblique flow of the river is expected to occur even during such flows.

Fig. 3 The Okhla barrage on the Yamuna River, Delhi.

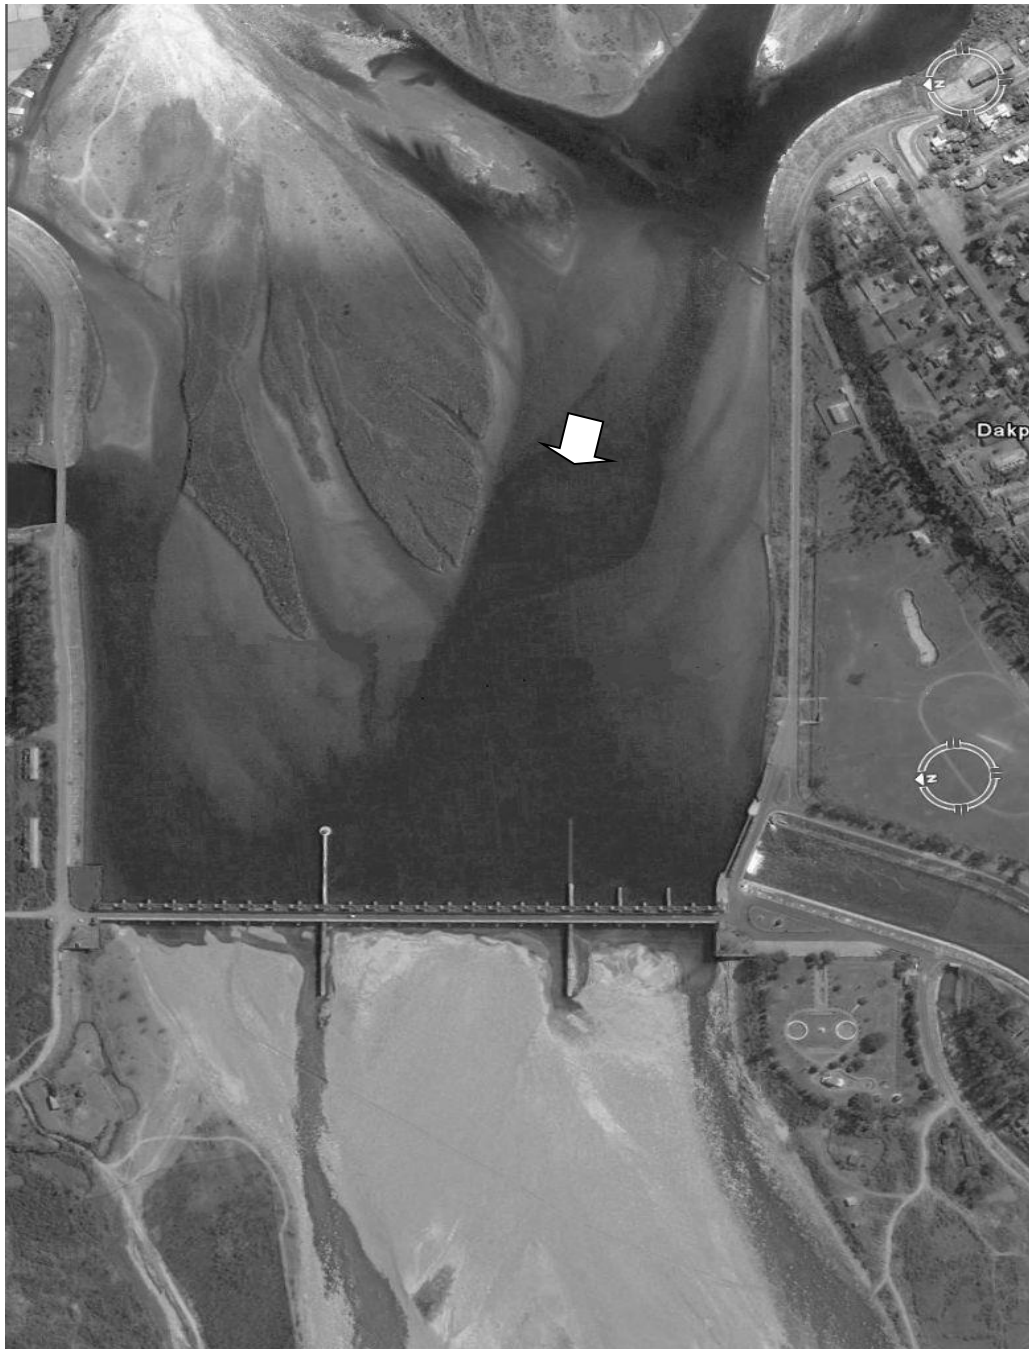
This barrage (Fig. 4), also on the River Yamuna, located in its mountainous reaches near the scenic town of Dakpathar in the Shivalik Hills, is used for diverting water into a power channel. The deeper section of the river is apparent towards the left bank, the side on which the off-take lies. The tail race of the Khodri power generation scheme joins the river slightly upstream of the barrage from the right. The water discharging from this tail race channel appears to have cleared some of the shoals towards the right bank. Also, since the waterway for the barrage has been kept smaller than that obtained by Lacey's method, the amount of shoal does not appear to be too threatening. Given that most of the water is diverted into the hydropower channel, the river appears rather dried up downstream, especially during the non-monsoon periods.

Fig. 4 The Dakpathar barrage on the River Yamuna.

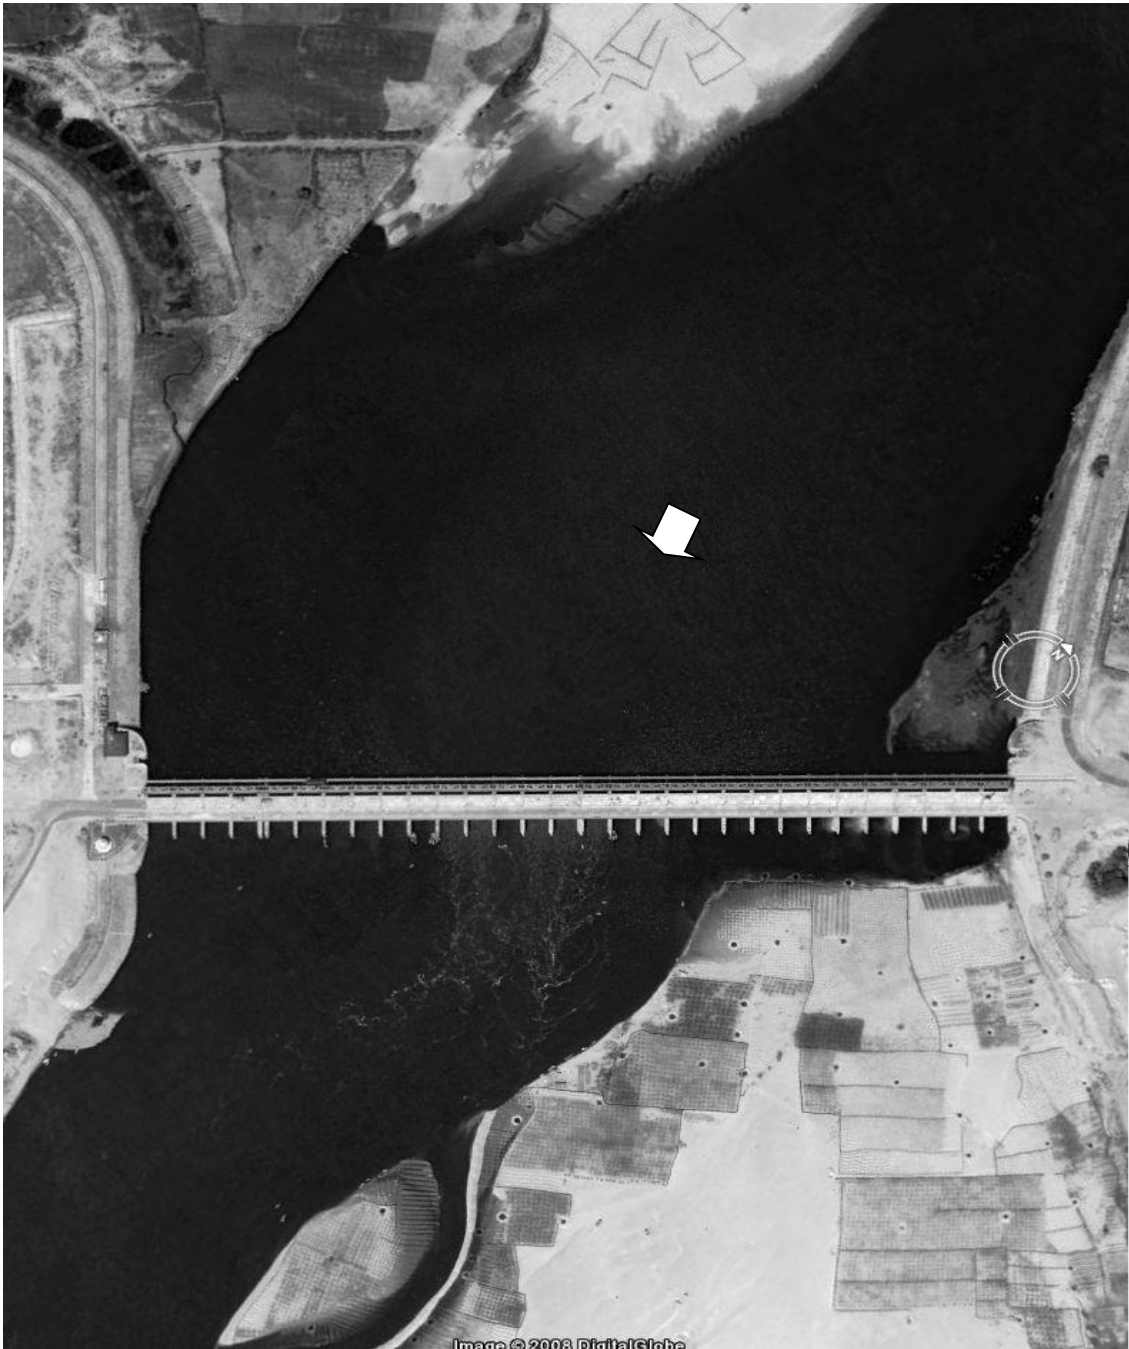
This barrage on the River Ganga (Fig. 5) was constructed relatively recently, for the supply of drinking water to the city of Kanpur (located near the right bank of the river). Although there are no visible shoal formations in the pool just upstream of the barrage, the river itself is seen to be strongly inclined to the barrage axis, a reason to produce oblique flow. This is also clear from the heavy sedimentation downstream of the barrage towards the left bank. A strong turn, by nearly a right angle to the axis of the barrage, may be observed for the flow emanating from the last few bays of the barrage to the left. Such a flow situation, which is nearly parallel to the barrage axis, is normally responsible for producing deep scour just downstream of the barrage gates.

Fig. 5 The barrage on the River Ganga near Kanpur.

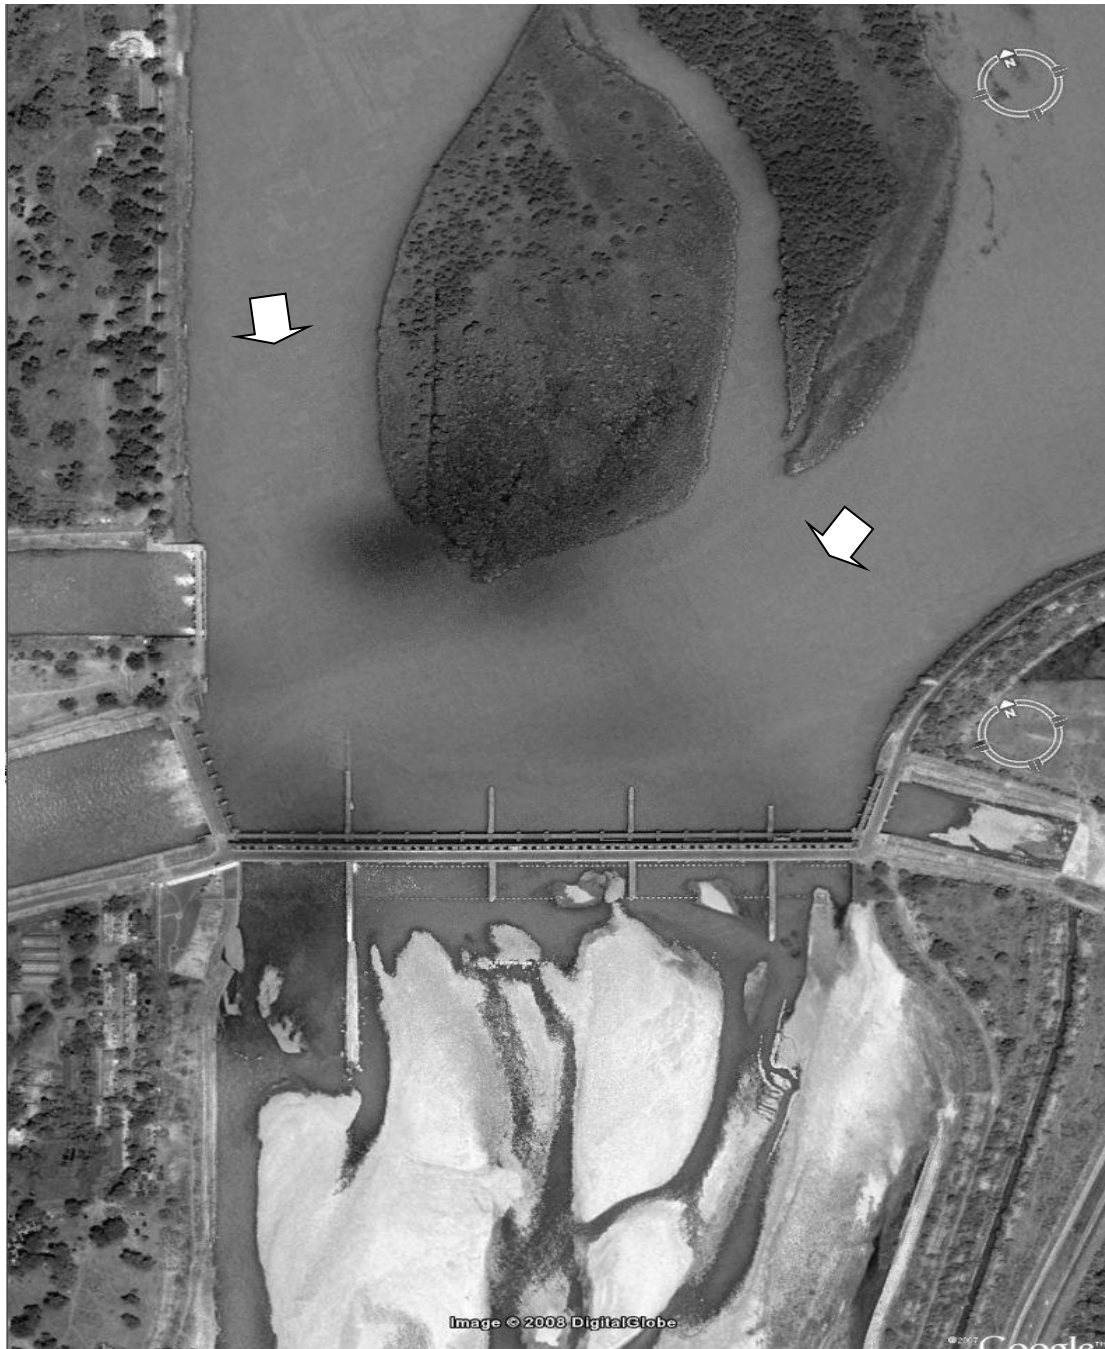
The Bhimgoda barrage on the River Ganga (Fig. 6) near the town of Haridwar, a Hindu pilgrimage, was constructed downstream of an older weir for diverting water into the eastern and western Ganga canals, off-taking from either bank. There is some visible sedimentation in the pool, but this is somewhat upstream of the barrage axis. However, closer inspection reveals that the flow of the river is somewhat inclined to the barrage axis. In the absence of the extended divide walls, the flow would be almost parallel to the barrage axis in the upstream pool nearer to the left bank of the barrage. As mentioned above, such a parallel flow may sometimes lead to a dangerous situation of causing deep scour on the downstream parallel to the gates.

Fig. 6 The Bhimgoda barrage on the River Ganga at Haridwar.

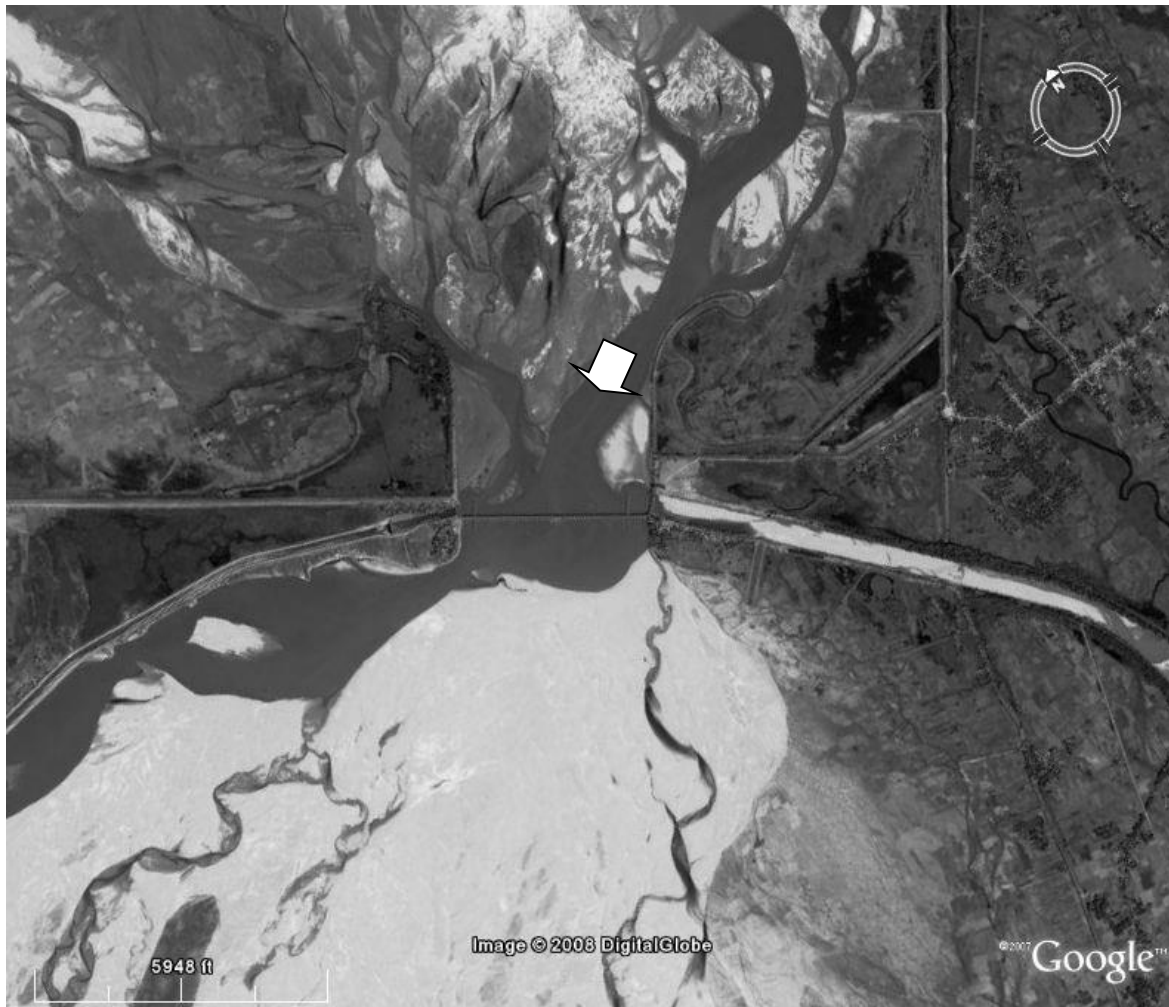
The Kosi barrage is located on the “alluvial fan” of the Kosi River as it descends onto the plains from the hills of the Himalayan nation Nepal (Fig. 8). This barrage probably faces the most critical situation regarding the effect of sediment deposition both upstream as well as downstream of the barrage. As is well known, the river has shifted westwards by about 150 km over the last 200 years and the trend seems to be still continuing, as can be seen from the flow of the river downstream of the barrage. In addition the main channel of the river upstream of the barrage is inclined substantially to the barrage. A very strong oblique flow is seen to exist across the barrage bays on the downstream. Interestingly, the canals can also be seen to be heavily silted, a problem which has been the subject of considerable research by water engineers over the past few decades. On 18

Fig. 8 The barrage on River Kosi, Himalaya foothills near India–Nepal border.

August 2008, a sudden breach of the left bank afflux embankment caused the river to flow unbridled and resulted in huge economic and material loss.
