## Quantification, analysis and modelling of soil erosion on steep slopes using LiDAR and UAV photographs

F. NEUGIRG<sup>1</sup>, A. KAISER<sup>2</sup>, J. SCHMIDT<sup>2</sup>, M. BECHT<sup>1</sup> & F. HAAS<sup>1</sup>

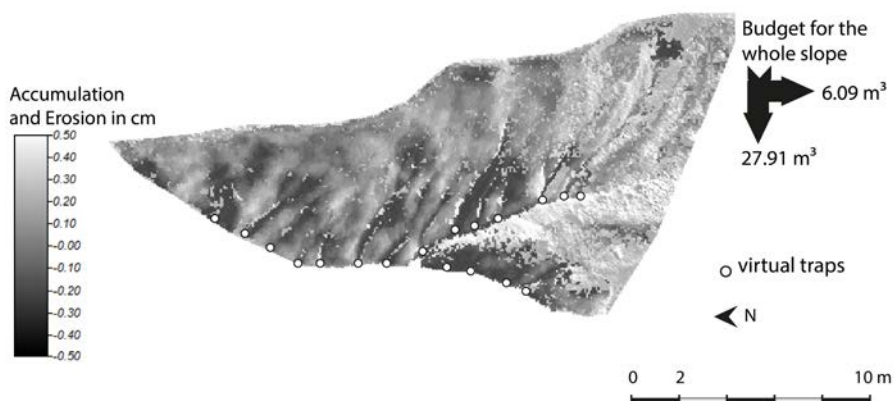
**Fig. 2** Erosion and accumulation estimates for the hill slope in the Lainbach valley from July 2009 to Oct. 2013. The arrows indicate the amount of material deposited on the slope and transported out of the study area. “Virtual traps” at the bottom of the gullies are represented by circles.

During the four year survey period between July 2009 and October 2013 (Table 2), a total of 34.0 m<sup>3</sup> of material were eroded of which 6.1 m<sup>3</sup> was deposited on other parts of the 265 m<sup>2</sup> hill slope. Scaling up, a total of 27.9 m<sup>3</sup> of mobilised sediment reached the channel network. The entire slope was lowered by 14.7 cm on average during the four-year study period. The annual lowering rates of 3.4 cm year<sup>-1</sup> lie in the range of values reported by other study areas with glaciogenic deposits in the Northern and Central Alps. For example, Haas (2008) reported 2.5 cm year<sup>-1</sup> in the Lahnenwiesgraben (Bavarian Alps) and Becht (1995) 4.3 cm year<sup>-1</sup> in the Horlachtal (Oetztal Alps). The highest erosion rates (>0.5 m) were measured at the foot of the gully slopes reflecting lateral fluvial erosion. In addition, areas with extensive erosion generated by non-fluvial processes were identified at the top and bottom of the study slopes (Fig. 2). Gullying occurred mainly on the lower part of the slope. The most extensive erosion areas might be the result of translational slides in connection with snow melt. This assumption corresponds with the conclusions of Becht & Wetzel (1992).

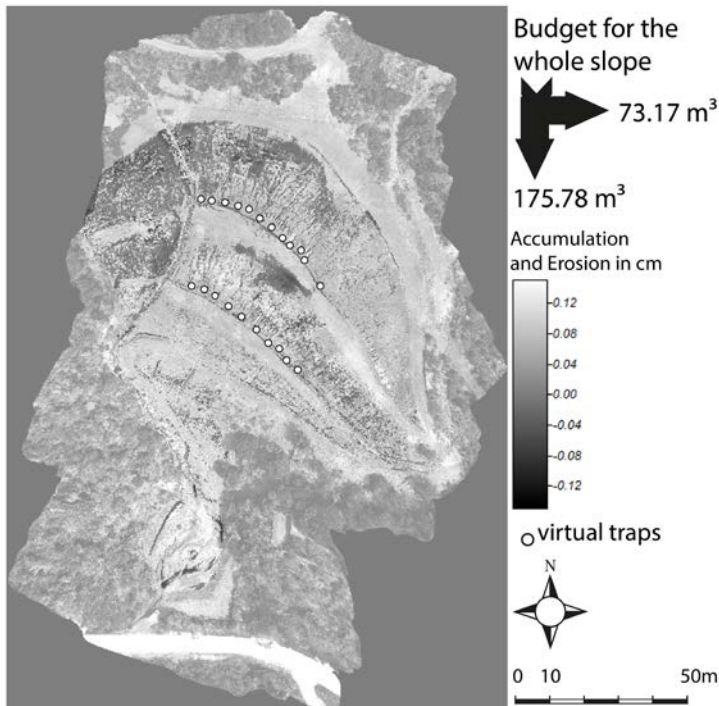
**Fig. 3** Erosion and accumulation estimates for the Rio Marina study site from Sept. 2009 to April 2012. The arrows indicate the amount of material deposited on the slope and transported out of the area. “Virtual traps” are represented by circles.

Erosion mainly occurred in conjunction with the heads of rills and artificial drainage channels. However, some parts of the slope were also subject to more extensive erosion, suggesting slope wash and small-scale slides. Break lines in the upper parts of the slopes suggested small-scale slope failures. Accumulation was focused on two parts in the flat area at the lowest points of the study slope (Fig. 3). In total (Table 3), 230.9 m<sup>3</sup> of sediment was eroded during the three year period between 2009 and 2012. Within the study area, 73.2 m<sup>3</sup> of sediment was redeposited. Due to the slope terraces and the flat plain in the lowest part of the mine, about 33% of the total eroded

material was re-deposited in the study area. A total of 157.8 m<sup>3</sup> of sediment was exported from the catchment. The average surface lowering for the entire slope was 3.9 cm for the three-year study period. The erosional pattern suggested the dominance of slope wash and rill erosion, which is in good agreement with the climatic conditions characterised by precipitation as rainfall, concentrated during winter. The presence of rill erosion confirmed the installation of stabilizing measures on the slopes, although it seems that debris flows cannot be stopped by these interventions.

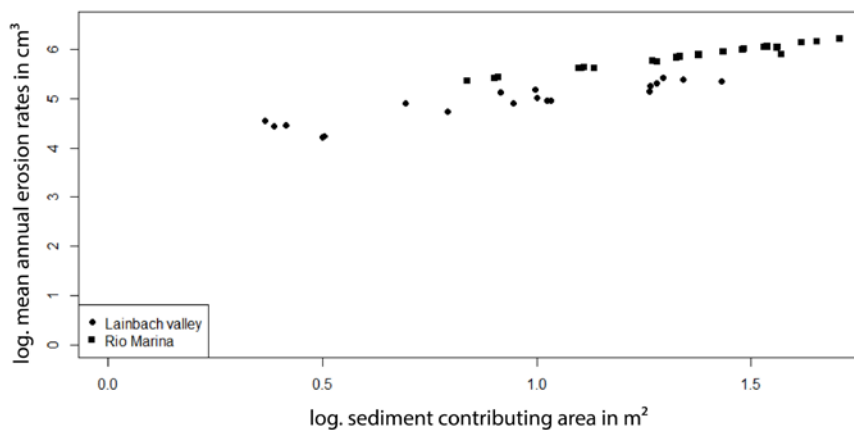
**Fig. 4** Relationship between catchment size and mean annual erosion rates for the Lainbach valley and Rio Marina hill slopes.

The annual sediment delivery was related to the corresponding SCA at 19 (Lainbach valley) and 29 (Rio Marina) “virtual traps” at the foot of the study slopes. Both study areas showed a very strong agreement between SCA (hydrological catchment) and annual erosion rates, with higher rates at the Rio Marina study site (Fig. 4).

Several factors such as different climatic conditions with different precipitation regimes, different soil compositions and structures, slope angles or slope length could be the reason for the gap between the two study areas and they need further detailed analysis in the following years.

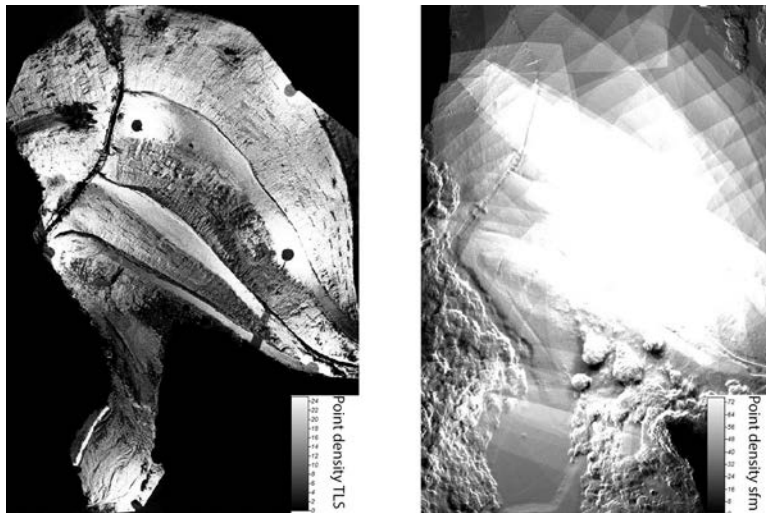
**Fig. 5** Point densities for the Rio Marina study site. Note different colour scales for TLS (left) and sfm (right). Values indicate point count for each grid cell (20 × 20 cm).

The point densities of the TLS and sfm data varied greatly. Generally, the sfm point densities were distributed very homogeneously over the entire hill slope, whereas the TLS point cloud showed very high densities around the scan positions and in overlapping areas. Thus, TLS point clouds were distributed heterogeneously over the entire slope. Due to shadowing effects, the TLS data were compromised by less or even missing values in the gullied parts of the slopes. As the geometric angle is more favourable for using an UAV, these shadowing effects can be minimized by using DEMs from sfm (Fig. 5).
