Erosional processes and sediment yield in the upper Oldman River basin, Alberta, Canada

ABSTRACT The upper Oldman basin descends eastward from the Continental Divide of the Rocky Mountains in southwest Alberta. Its 4000 km² area can be divided into Mountains, Foothills and High Plains. The paper discusses its sediment yield and the associated erosional processes. Suspended sediment yield averages 70 t km⁻² year⁻¹, but varies greatly from year to year. This compares with a range of 20-100 elsewhere in Alberta and 0-350 in Canada generally. Principal erosional features identified include stream channel instability, ravine erosion, grassland gullyng, wind erosion, and gravity-induced mass movements. An assessment of information obtained from airphoto interpretation and field reconnaissance indicates that erosional features are generally local in extent and are not creating widespread distress, that most present erosion is associated with streams and rivers, and that a substantial part of this is of natural geologic origin. The main source of man-made erosion appears to arise from public roads and associated interference with natural drainage. A potential for accelerated erosion appea

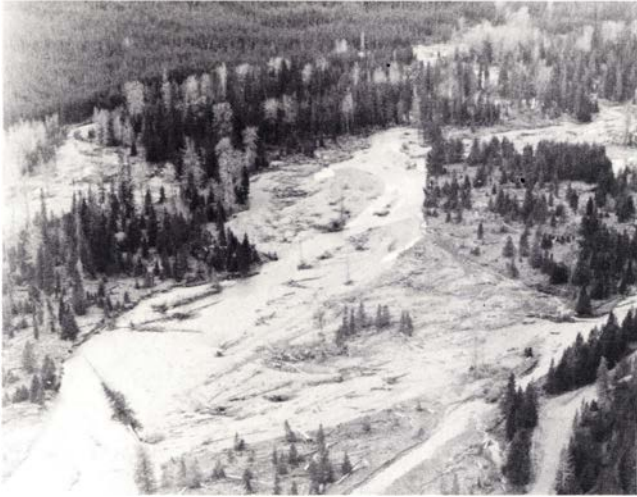
(a) Stream channel instability in mountain valleys (Fig.3). This is typical of areas where forest cover has been removed from stream banks because of fires or infestation. Current harvesting practice leaves protection strips along streams. Sediment derived from such instability is mainly coarse bed load that does not travel far down the system.

FIG.3 Channel instability along upper Castle River in mountain valley.

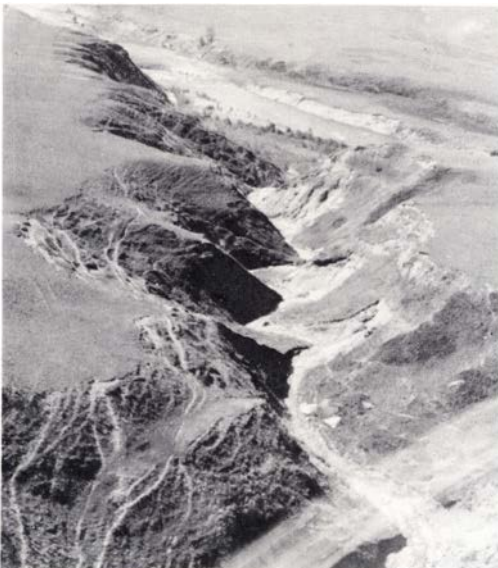
(b) Ravine erosion in tributary streams draining areas of grazing land (Fig.4). This may have been accelerated by faster runoff from short-grass land and by cattle browsing and trampling on ravine slopes.

FIG.4 Ravine erosion in Oldman River tributary.

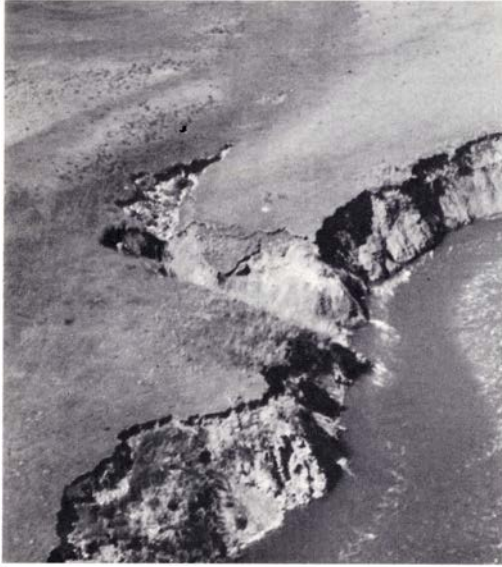
(c) Incipient gullying in grazing land: Figure 5 shows recent gully development resulting from careless diversion of road drainage across fields. Also evident is river bank erosion in thick deposits of glacial materials.

FIG.5 Recent gully development and bank erosion in glacial materials

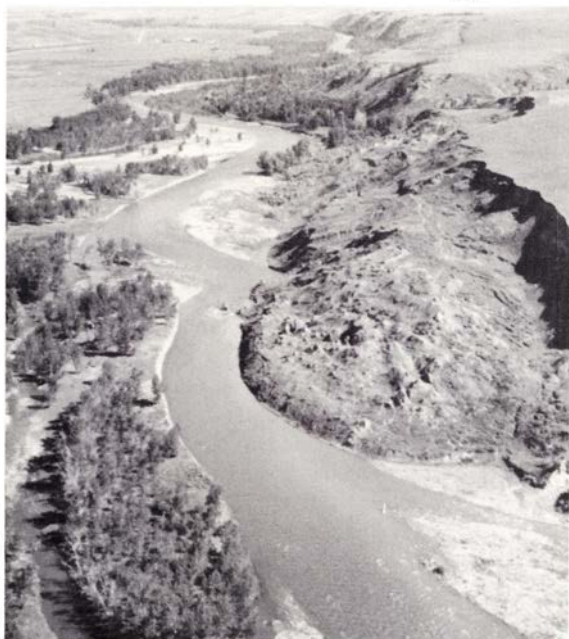
(e) Gravity induced erosion. Particularly along the valley of the Oldman River north of the Three Rivers site, there is massive slumping of valley sides where the river attacks the toes of slopes and removes slumped material (Fig.7).

FIG.7 Recent massive landslide on Oldman River north of Three Rivers site.

The Oldman, Crowsnest and Castle Rivers through most of the Foothills and High Plains segments are downcutting in either bedrock or glacial drift. Much of this downcutting occurs within buried valleys that are presently being re-excavated by the rivers. Deep-seated landslide activity is mostly associated with two bedrock formations that contain weak bentonite layers in shale, siltstone and sandstone strata. When the rivers undercut these formations, sliding towards the river tends to occur. The recent massive slide shown in Fig.7 is believed to have been triggered by a particularly large flood in 1975.
