Monitoring of suspended sediment concentration in discharge from regulated lakes in glacial deposits

E. TESAKER & T. E. DAHL
SINTEF NHL Norwegian Hydrotechnical
Laboratory, N 7034 Trondheim, Norway

ABSTRACT Following extensive regulation for hydropower, serious erosion along the shores of some lakes was observed. Obvious reasons were bank erosion from waves, ground water flow, and degradation of tributaries. A monitoring programme was established at three typical lakes: Suspended sediments; Time development of bank profiles; Aerial photos of tributary deltas; Regular photo recording of selected spots. The programme was most intensive from 1973 to 1980, but is still being followed up at intervals. Among the findings are: a) Sediment concentrations vary seasonally and with hydrological conditions e.g. water levels, wave activity, ice cover, tributary discharges, and surface runoff, but also regularly decrease with time. b) Bank erosion depends on depth, wind/wave direction, natural armouring, and gully formation from groundwater flow. c) Degradation of tributaries is related to drainage area and soil composition. Only a) will be reported.

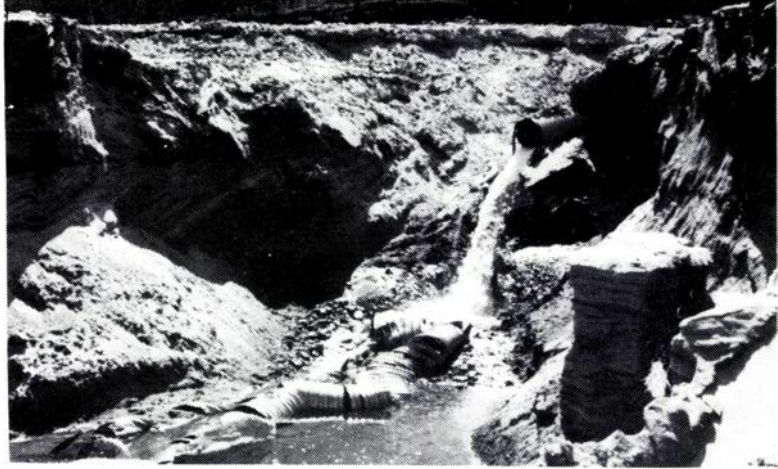
FIG. 1 Creek degradation and unsuccessful repair attempt, Gjevilvannet.

Figure 1 shows creek degradation, where an unsuccessful attempt has been made to stop it by pipe installation. Figures 2-3 show wave and groundwater erosion, from the same site in 1974 and 1986.

Rapid degradation of the tributaries started right after the first drawdown. Some of the major tributaries were then permanently protected against further erosion, while some more amateurish attempts to stop erosion in minor creeks were wasted, Fig. 1. A gradual flattening of the exposed shoreline has occurred, and the minor creeks have now developed a rather stable profile, too.

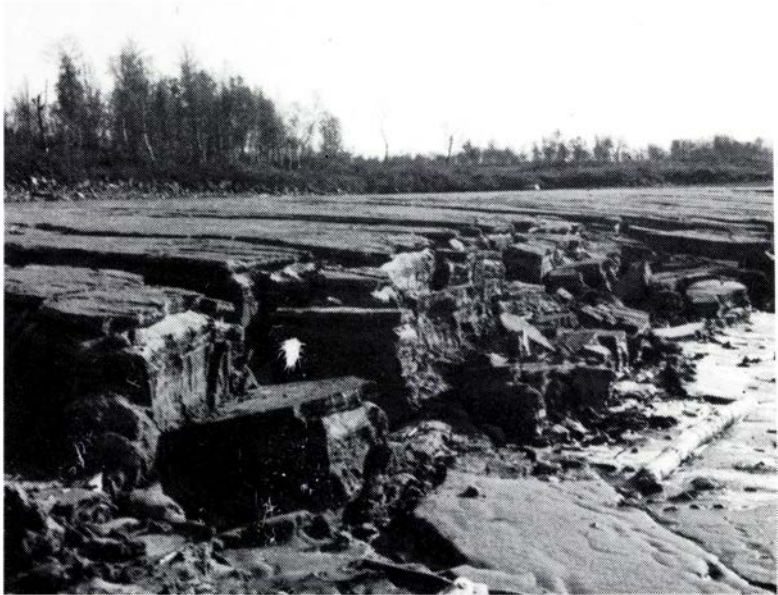
FIG. 2 Wave and groundwater erosion, Devdisjavri 1974.

different lapse of time. Particularly the undercutting process caused by continual wave attack at low water levels will delay the development of a new stable situation in these lakes, Fig. 2.

A narrow strip of the bed along the natural shoreline was covered by a stable armour layer of sorted out gravel. The regulation, 0.8 m up and 14.2 m down, exposed large areas of unprotected bottom below the armour layer to wave action and groundwater erosion, similar to the situation shown in Fig. 2.

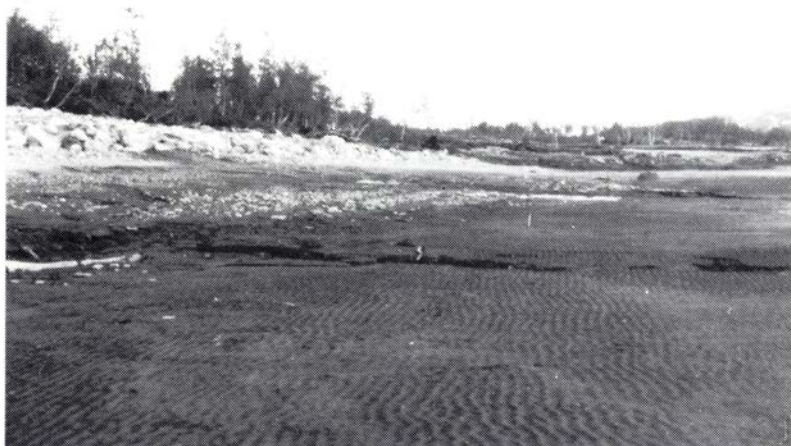
FIG. 3 Devdisjavri 1986. Same site as Fig. 2.

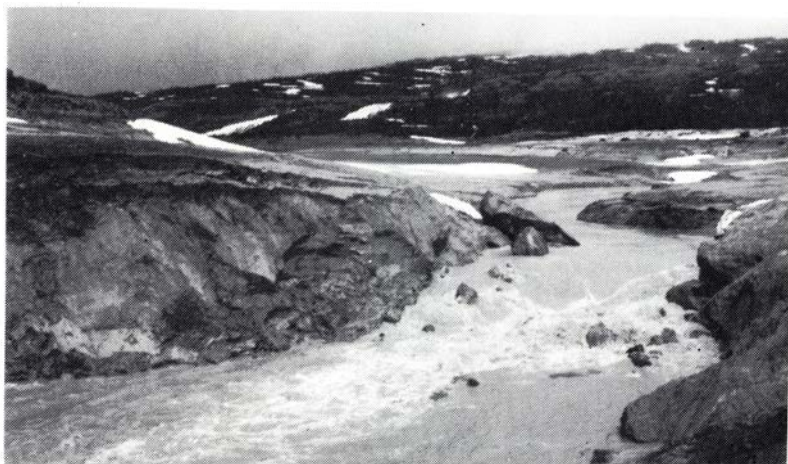
FIG. 7 Erosion of the passage between basins I and II of Målvatna.
