Land use change, conservation measures and stream channel response in the Mediterranean/semiarid transition zone: Nahal Hoga, southern Coastal Plain, Israel

Abstract Photographs taken in 1917 by a Royal Flying Corps plane during an intelligence mission beyond the Ottoman frontline document, for the western part of the Nahal Shiqma catchment in the southern Coastal Plain of Israel, a barren, highly eroded landscape with patches of primitive cultivation, active badlands, and widely braiding stream channels. Nahal Hoga, a 65 km² catchment representative of this area. was selected to monitor and explain the fluvial transformation which affected the region following the abrupt changes in land use associated with the wave of Jewish settlement 50 years ago. This was accomplished through a detailed field, air photo, and GIS-based evaluation of the areal land use and stream channel geometry repeated at decadal intervals. While the 1945 channel morphology and land use were similar to those in 1917, subsequent transformations, caused by land use changes and conservation measures, were dramatic. Channels narrowed drastically and were stabilized by encroaching vegetation. The braided pattern w

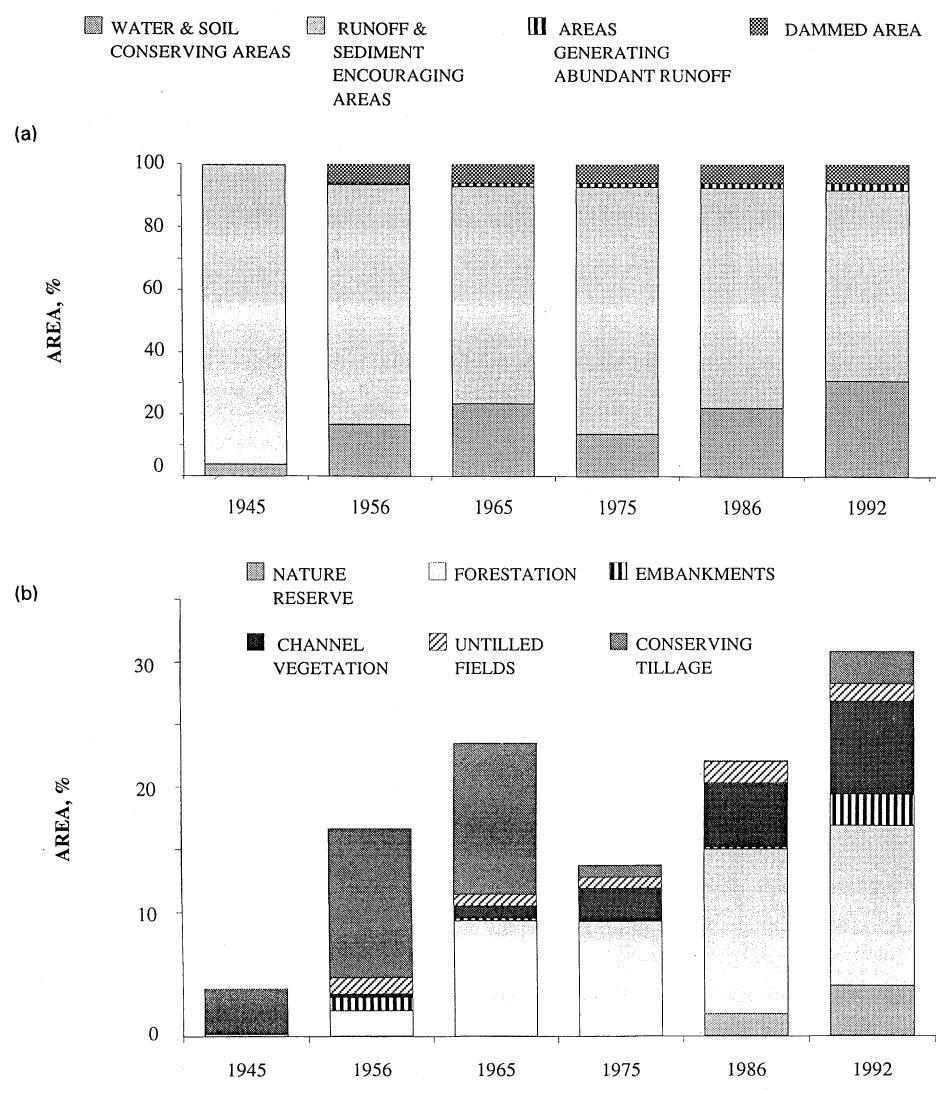
Fig. 3 Land use, Nahal Hoga catchment, 1945-1992: (a) total area; (b) land with conservation practices; (c) land with cover enhancing runoff and erosion.

The transformations of the land use in the Nahal Hoga catchment can be generalized into four periods (Fig. 3, Table 1):

- (a) Prior to 1948, the slopes, badlands and channels were completely bare (no vegetation) due to overgrazing. Afforestation is non-existent and cultivation occurs on very small areas and is predominantly traditional.

- (b) From 1948 to 1965 vegetation started to reappear, especially in the badlands and in the vicinity of the channels. Grazing was limited and controlled. Afforestation was beginning. Most of the agriculture is soil- and water-conserving cultivation.

- (c) From 1965 until the end of the 1970s an increase in grazing density (in terms of heads of sheep and goats per unit area) occurred, although grazing was still controlled and far removed from the overgrazing pattern of the 1940s. The soil- and water-conserving cultivation was gradually abandoned in favour of conventional cultivation, especially on the slopes. In the badland areas and along the channels conservation methods were continued.

- (d) From the early 1980s until 1992 the grazing areas were drastically reduced, and livestock numbers per unit area were also reduced. The vegetation in unused areas

increased in density. The badland area, which was always problematic for cultivation, became a nature reserve and afforestation was extended to new areas. The main conservation effort was redirected from the slopes to areas along the channels and to the badlands.

Focusing on the effects of land use on water and sediment yields, the development scenario of the drainage basin over the last half-century can be divided into three major periods (Fig. 3):

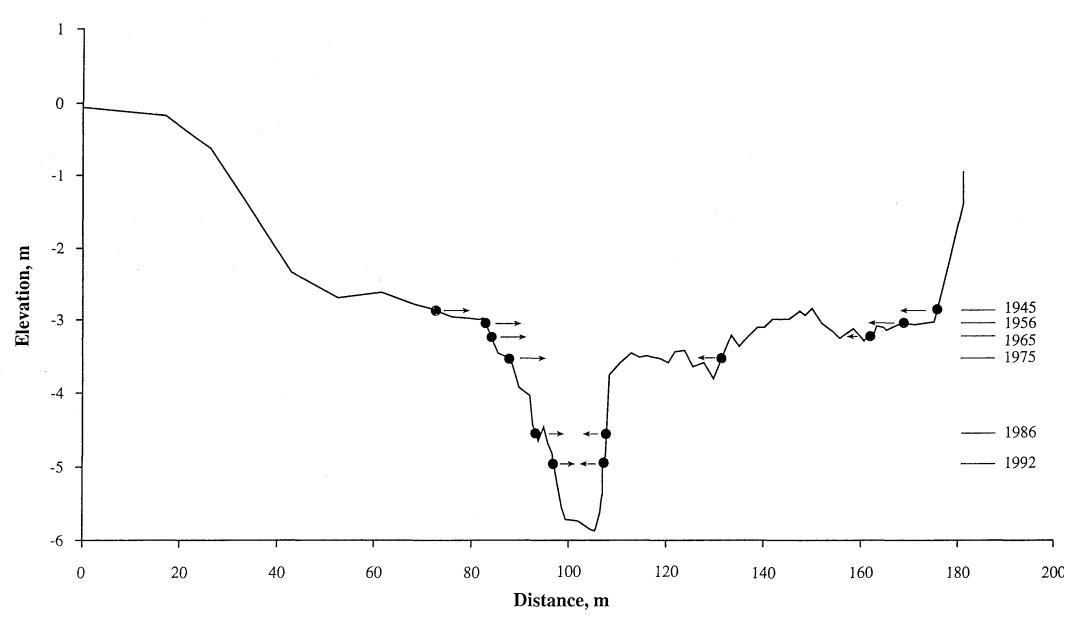
Fig. 5 Representative cross section, Nahal Hoga channel. Points on graph are channel banks as identified both in the field and on aerial photographs for each of the six years shown.

Extreme changes in the morphology of the Nahal Hoga stream channel are evident on the temporal (1945-92) series of aerial photographs (Fig. 5). The area of the active channel in 1992 was only 16.7% of the 1945 value, and the mean width was reduced from 66 m in 1945 to 11 m in 1992. The channel pattern changed from braided to quasi-meandering. From zero vegetal cover in 1945, the active channel area became fully covered with vegetation by 1992, with the exception of the inner active channel bed. Field measurements tied to points identified on current and earlier aerial photographs revealed considerable entrenchment, which ranged, for the period of study, from 0.8 to 2.9 m. Mean vertical incision from 1948 to 1993 was calculated as being 1.65 m, or 3.5 cm year⁻¹ (Fig. 6). A modest decrease in channel slope is suggested by the data, e.g. from 0.0093 (1945) to 0.0086 (1992) in a relatively steep reach and from 0.0065 (1945) to 0.0059 (1992) in an "average" reach, but the change may not be significant.

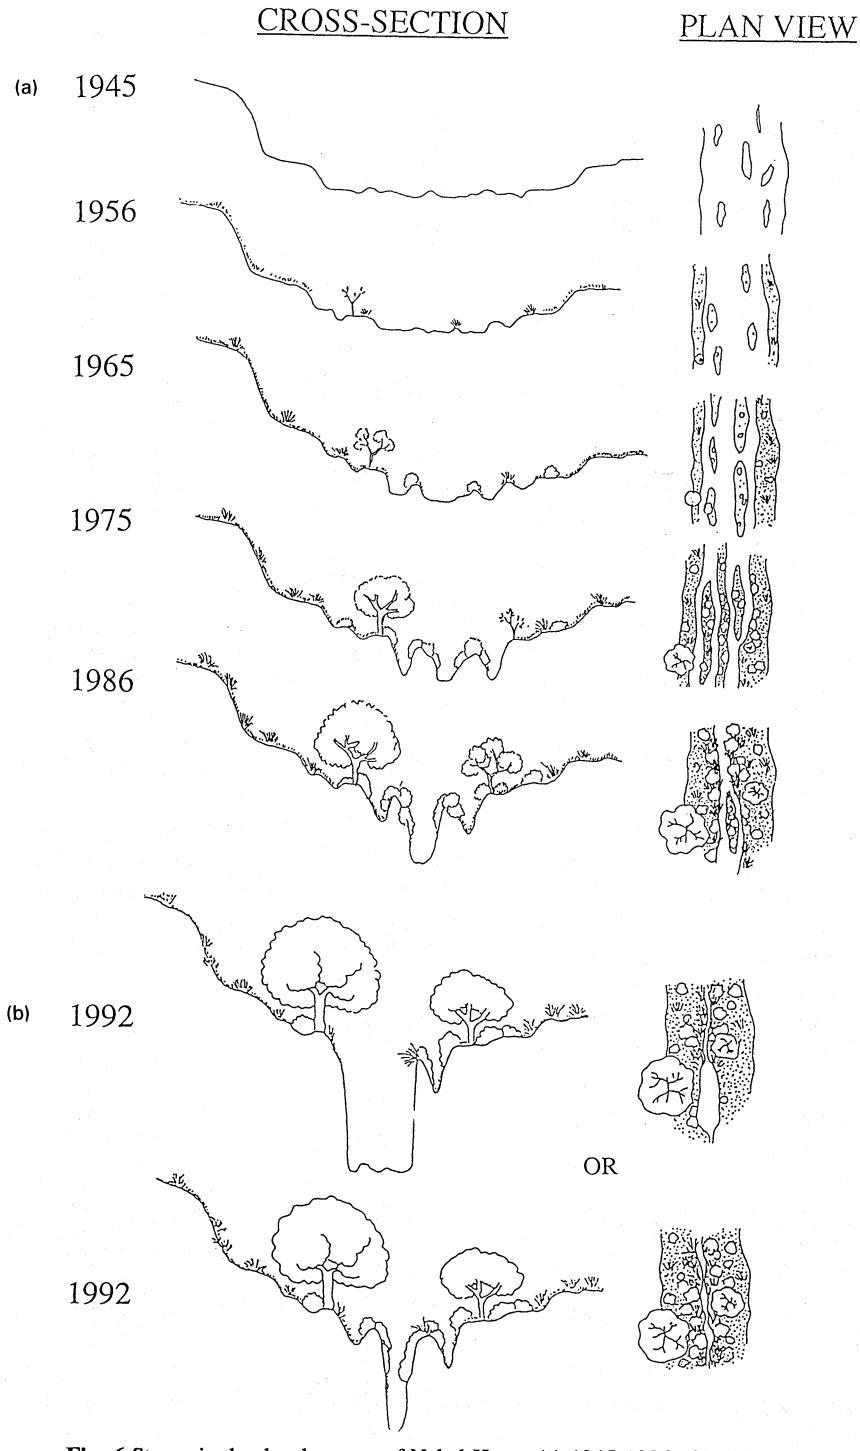
Fig. 6 Stages in the development of Nahal Hoga: (a) 1945-1986; (b) 1992. There are two variants for the 1992 situation. Sections are shown with a schematic vertical exaggeration.

The development of the Nahal Hoga channel can be reconstructed to provide the following six stages (Figs 7 and 8):

- (a) 1945: the channel is wide, bed topography is shallow and clear of any vegetation. The in-channel bars are not stabilized.
- (b) 1956: the beginning of a narrowing process is evident, with some development of vegetation on the banks, on channel segments abandoned by the active channel since 1945, and on some in-channel bars. The main channel is still quite wide, but its lateral bars are beginning to stabilize.

(c) 1965: some bars are already fully stabilized, with the density of vegetation on them increasing.

Narrowing of the channel progresses by the coalescing of previously distinct vegetated bars or flood plain tracts. The channel begins to divide into a number of narrow and incised sub-channels, although the main, wide channel is still very much in evidence.

- (d) 1975: The coalescing of the in-channel bars dominates. There are a number of flow trajectories between them. Vegetation expands overall and creates large continuous tracts, joining bars, flood plain areas, and banks.
- (e) 1986: Along most of the length of the Nahal Hoga there is a single channel, characterized by intense narrowing and deepening. The vegetation along both sides of this channel becomes very dense and now provides an uninterrupted longitudinal continuum.

(f) 1992: Along most reaches the narrowing and deepening trend is continued. Exceptions are certain reaches affected by the major floods of 1990-1991 and 1991-1992, in which the incision is accompanied by some widening. The vegetation is now clearly delimited in strips, with herbaceous and annual plants on the channel margins, various bushes somewhat higher on the banks, and an occasional, often large, tamarisk or sycamore tree in between. The narrow channel bed is bare, with a few sporadic *Acacia cyanophylla*. The appearance of a few remnants of pre-1945 fruit trees (vines, pomegranate, almond) reflect the dynamics of the lateral channel changes which had occurred since their planting.

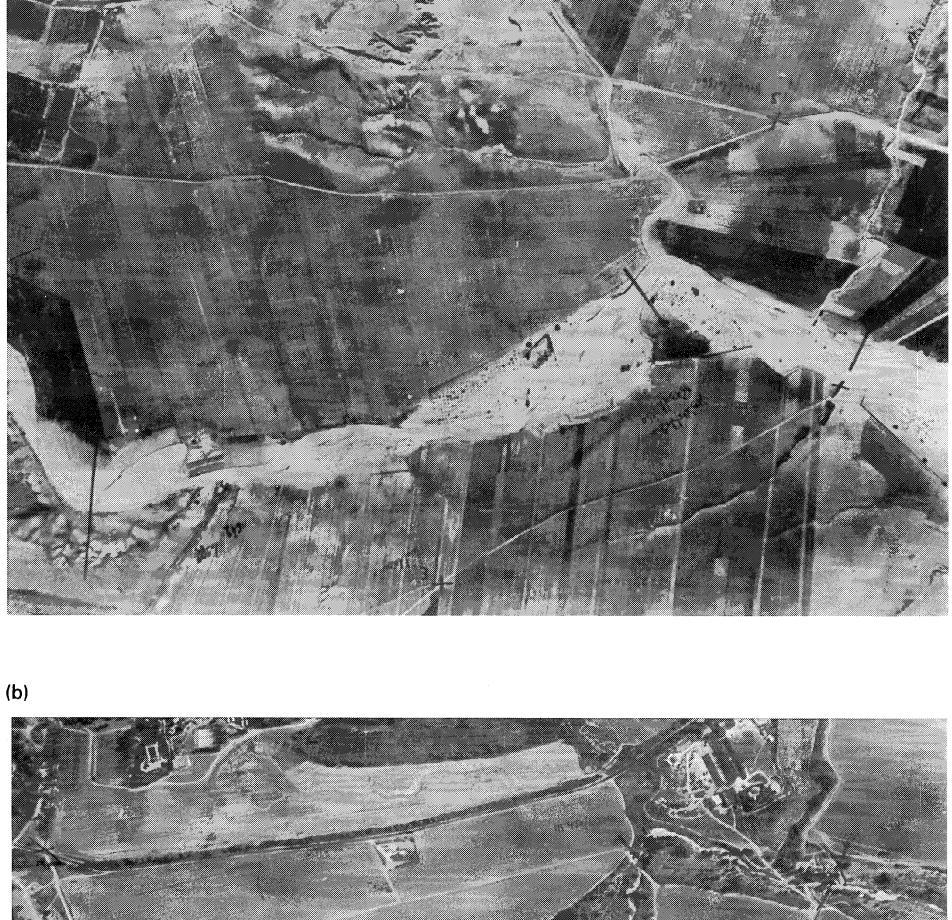
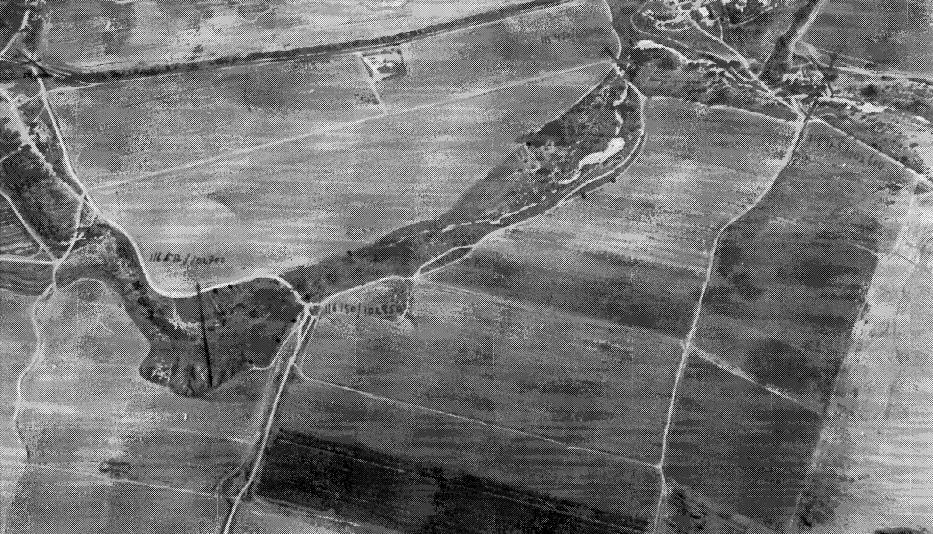
Fig. 7 Aerial photographs, Nahal Hoga channel: (a) 1945; (b) 1992.

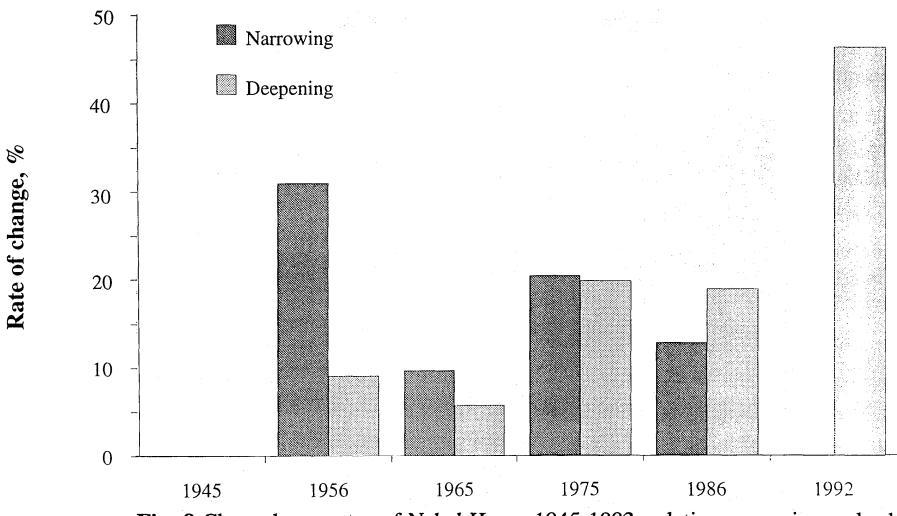
Fig. 8 Channel geometry of Nahal Hoga, 1945-1992: relative narrowing and relative deepening. Bars are 10-year changes (except 1986-1992 – a six-year change) and relate to the total (100%) change.

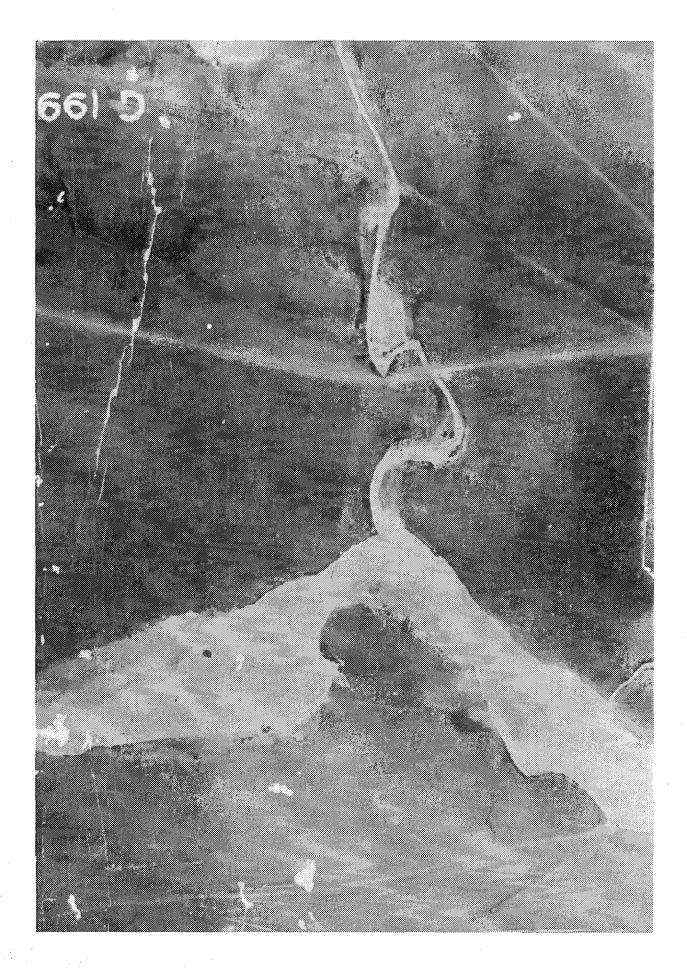
Fig. 9 Nahal Hoga channel, 1917. Photographed during a World War I military mission by the British Royal Flying Corps.

A British military aircraft on an intelligence mission searching for a German army airstrip during the World War I Middle East campaign provided a series of nine photographs in the vicinity of the subsequently abandoned village of Huj. These rare photographs cover part of the catchment of Nahal Hoga. They were taken in the summer of 1917 and the terrain is completely bare. The only land use discernible is grazing, and the area is severely dissected by active badlands.

Four of the cross sections surveyed and evaluated for each of the six time horizons of this study coincide with the short segment of Nahal Hoga which appeared on the 1917 air photographs (Fig. 9). A comparison shows that the 1917 channel was essentially identical to that in 1945, with the 1917-1945 changes being negligible in relation to the 1945-1956 changes. Looking at the 1945-1975 changes (a period of 30 years, and of

The aerial photographs of 1917 show conclusively that there were no significant changes in channel form between 1917 and 1945. In contrast, the changes after 1945 were such that already in the first decade they were very significant, in tandem with major changes in land use in the catchment. These changes continue to the present, and were more marked in the first 30 years - a period during which land use changes were particularly evident.
